ATM Door LINVAT

Series	070	Ordering No.	07012-UA24-0001
Projection E	DN	Flange	U
Dimensional Drawing	50x336	Rev.	A
	921102

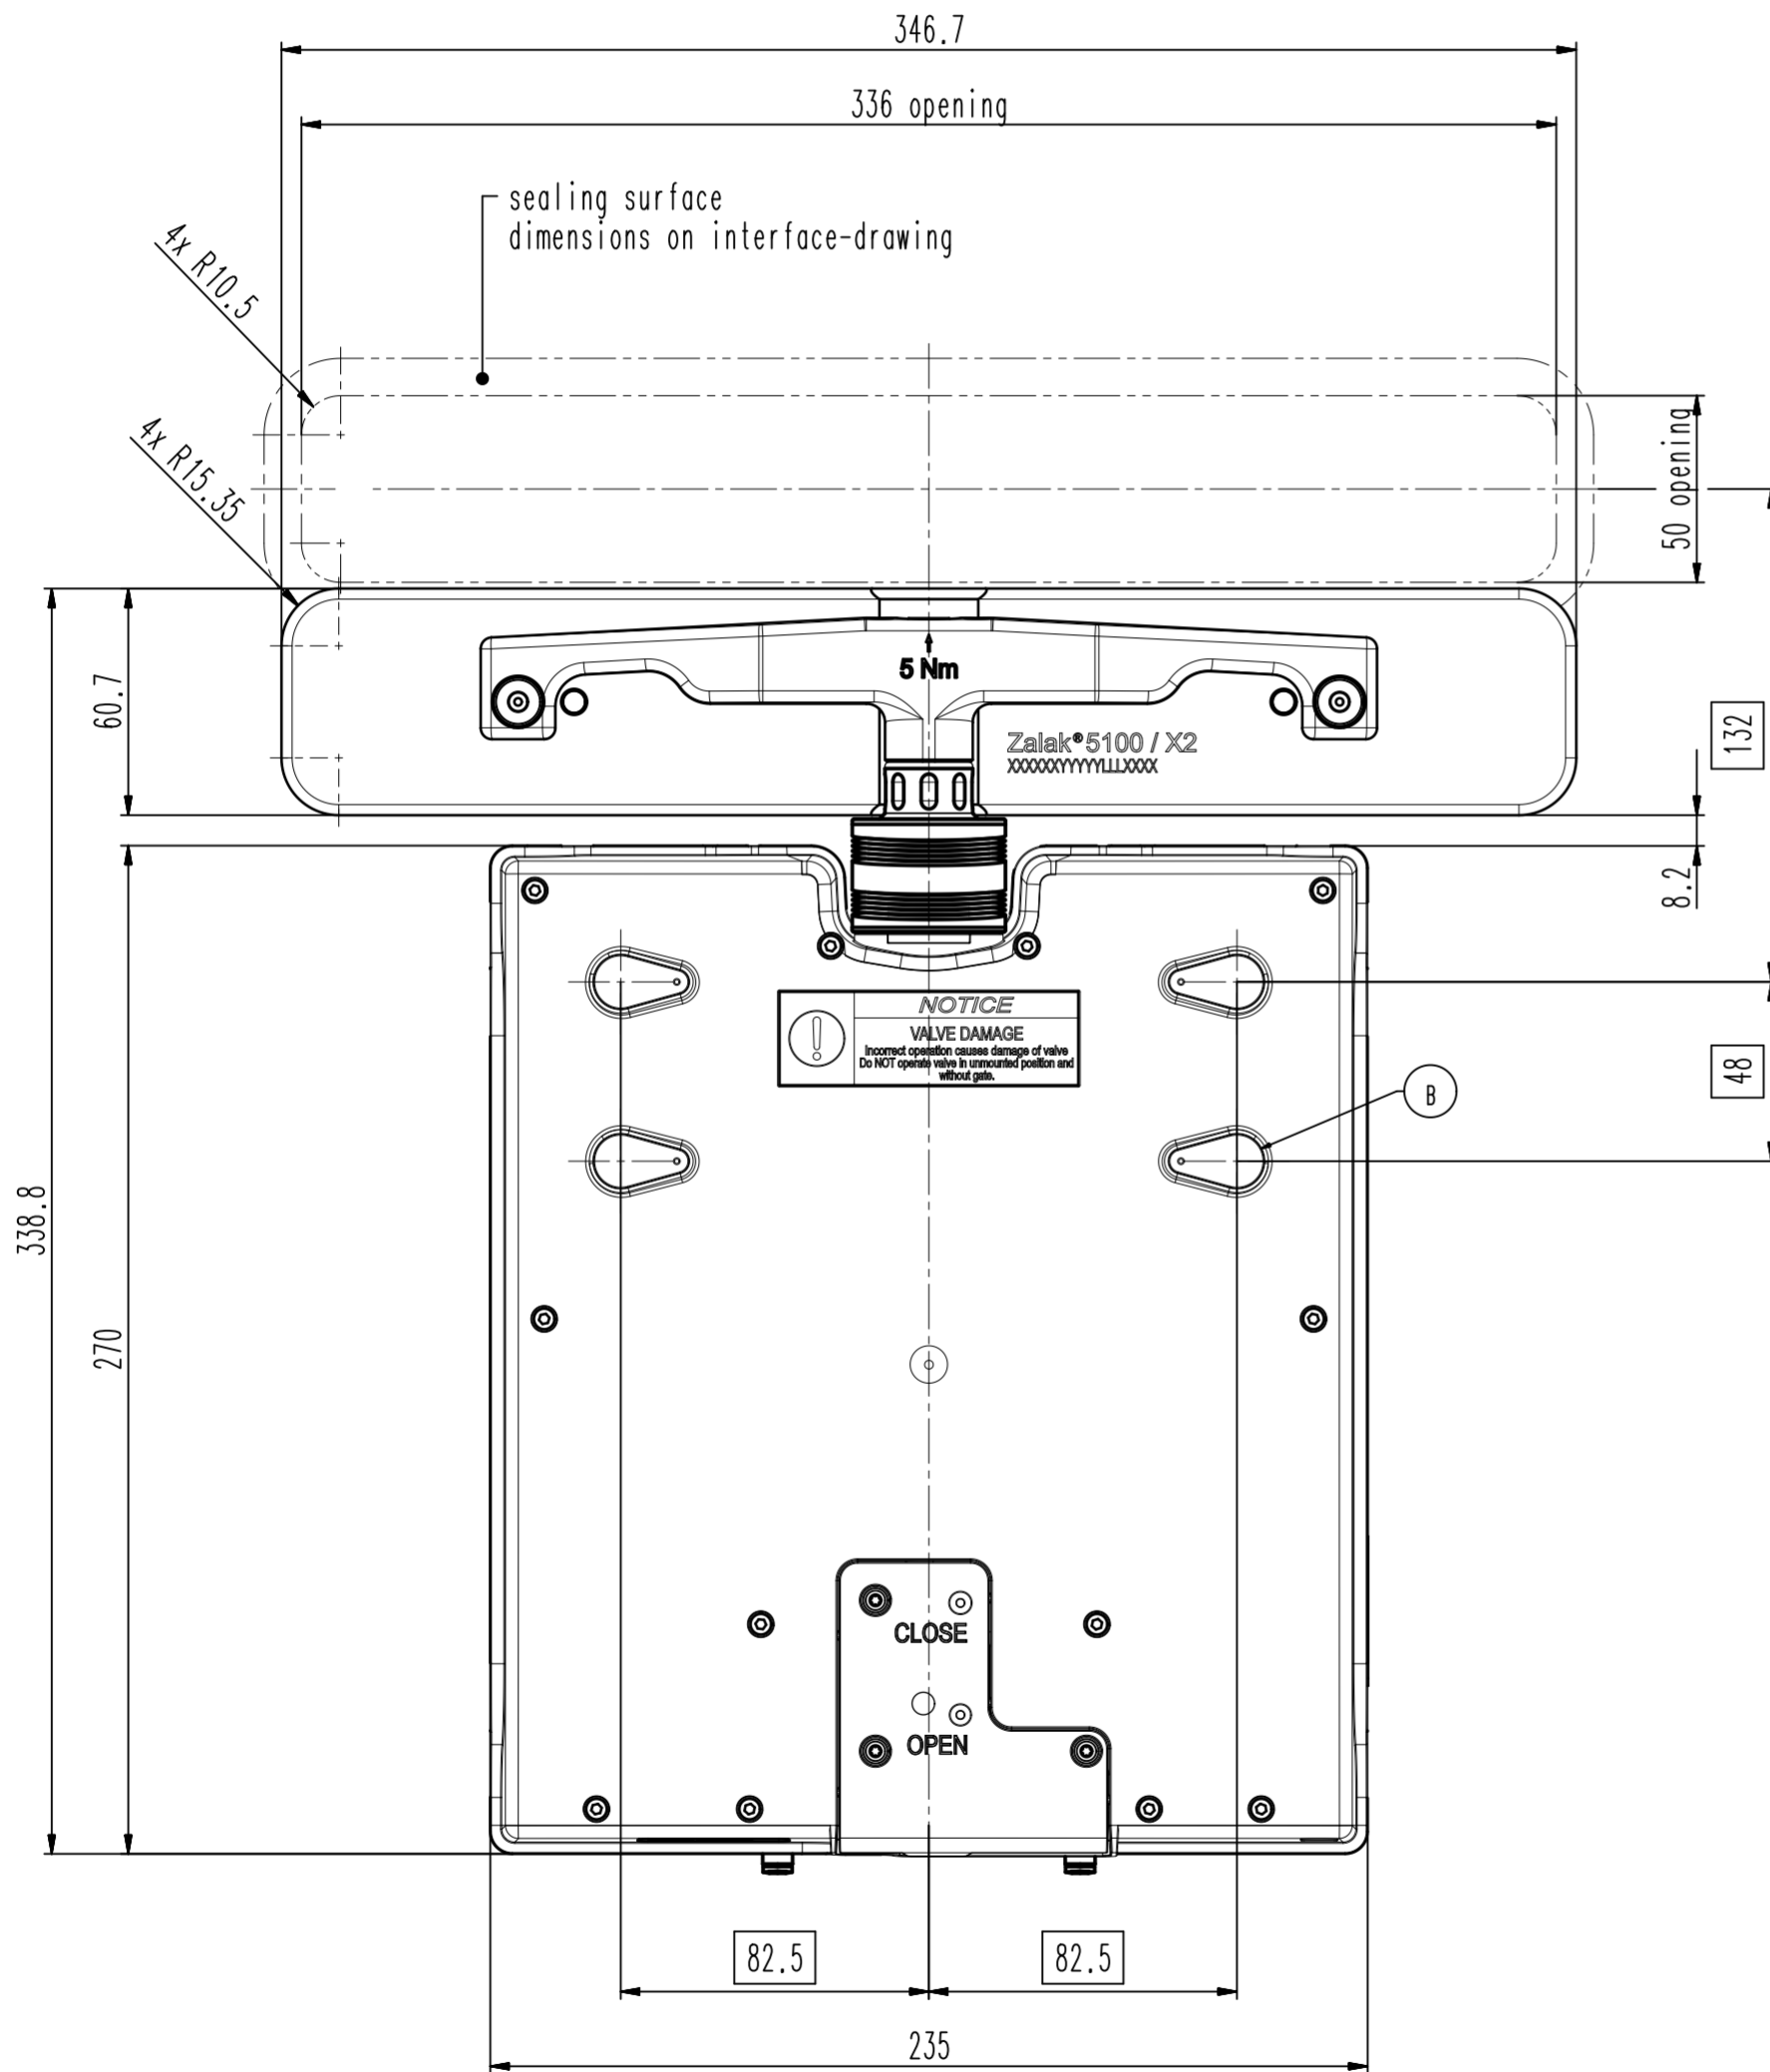
socket head cap screws
 M6x15 A4-80
 torque 8Nm

- ▼ Seat side
- ⊙ Comp. air connection
- ⊙ Electrical connection
- ⊙ Leak detection port
- ⊙ Mech. pos. indication
- ⊙ Position indicator
- ⊙ Required for dismantling
- ⊙ Emergency actuation
- ⊙ For attachment
- ⊙ Bake-out area
- ⊙ Differential pumping port
